## Northern Bribie Island

### What are the potential risks from a tidal breakthrough?

The *Bribie Island Tidal Breakthrough Risk Assessment Study* was undertaken to gain a better understanding of the risk associated with a tidal breakthrough of northern Bribie Island. This is a summary of the key findings from the study.

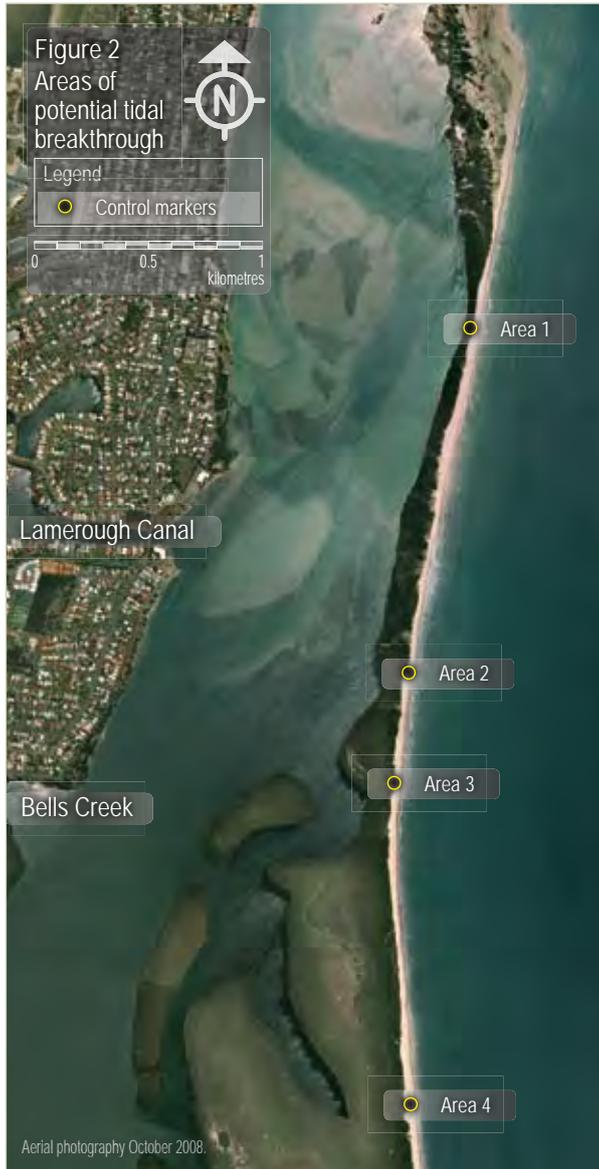
Along the northern end of Bribie Island four locations have been identified by DERM which are considered vulnerable to a breakthrough. The four locations are narrow with low dunes and have experienced major wave overtopping events in the last two years (refer to Figure 2).

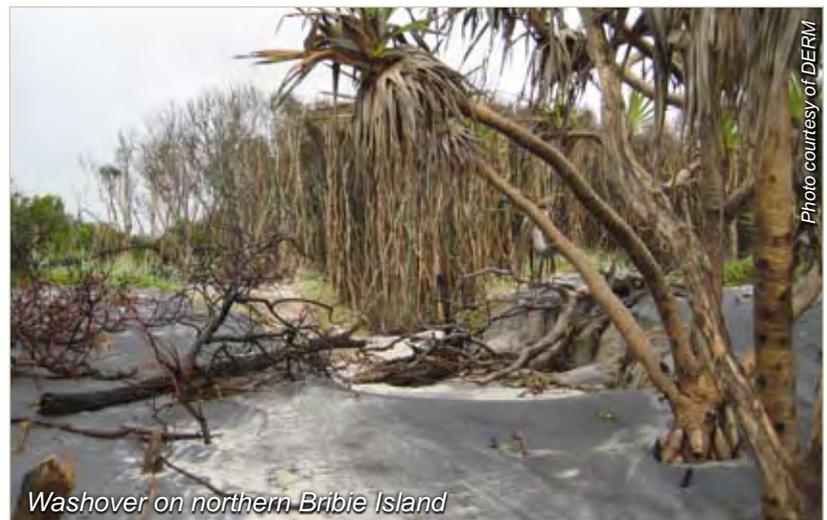
Washover on northern Bribie Island

In this instance a tidal breakthrough is when storm waves wash across northern Bribie Island lowering the dunes. As the level lowers tidal flows can then continue to deepen the channel which forms a new deep entrance to Pumicestone Passage. The process may take days or years and is dependent on weather and tide conditions, especially storms and cyclones.

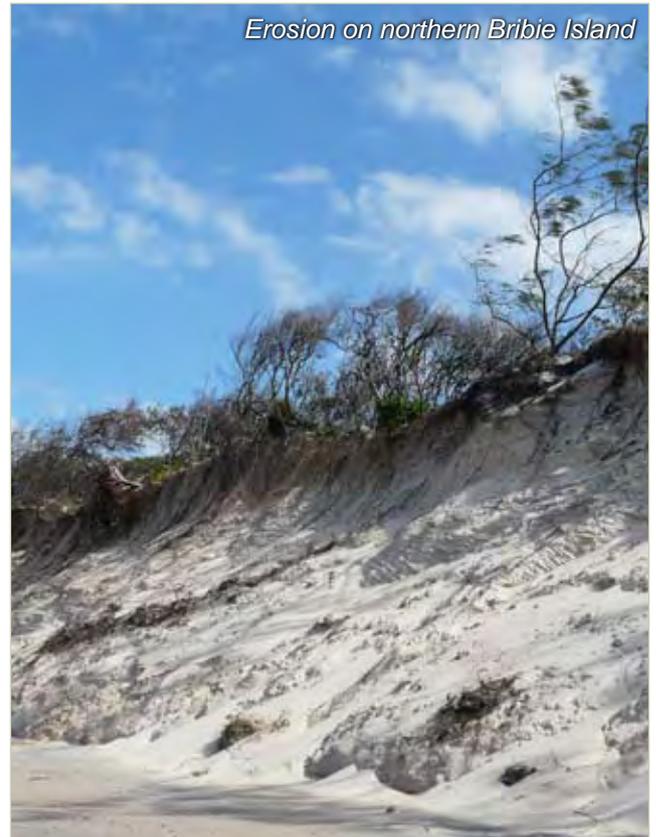
Erosion on northern Bribie Island

The northern five kilometres of Bribie Island has narrowed by up to 100 metres since 1948. The Department of Environment and Resource Management (DERM) states that the erosion appears to be a long-term natural process measured in the hundreds and perhaps thousands of years.

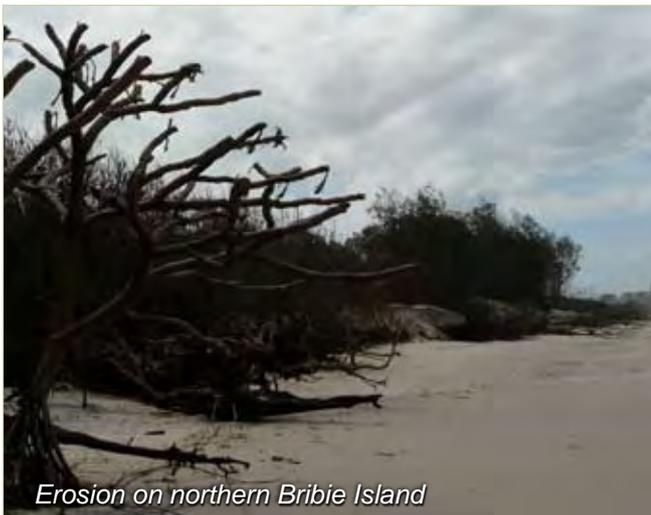
*Erosion on northern Bribie Island*
