## Northern Bribie Island

### What are the potential risks from a tidal breakthrough?

The *Bribie Island Tidal Breakthrough Risk Assessment Study* was undertaken to gain a better understanding of the risk associated with a tidal breakthrough of northern Bribie Island. This is a summary of the key findings from the study.

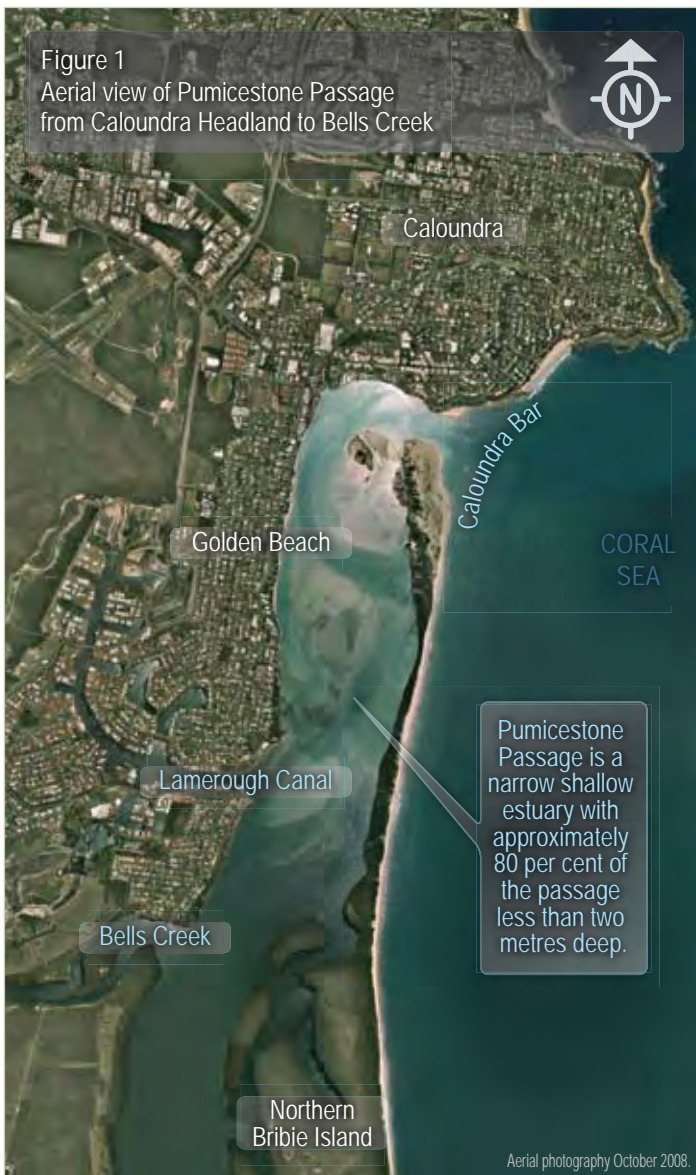
Figure 1  
Aerial view of Pumicestone Passage  
from Caloundra Headland to Bells Creek

Pumicestone Passage is a narrow shallow estuary with approximately 80 per cent of the passage less than two metres deep.

Aerial photography October 2008.

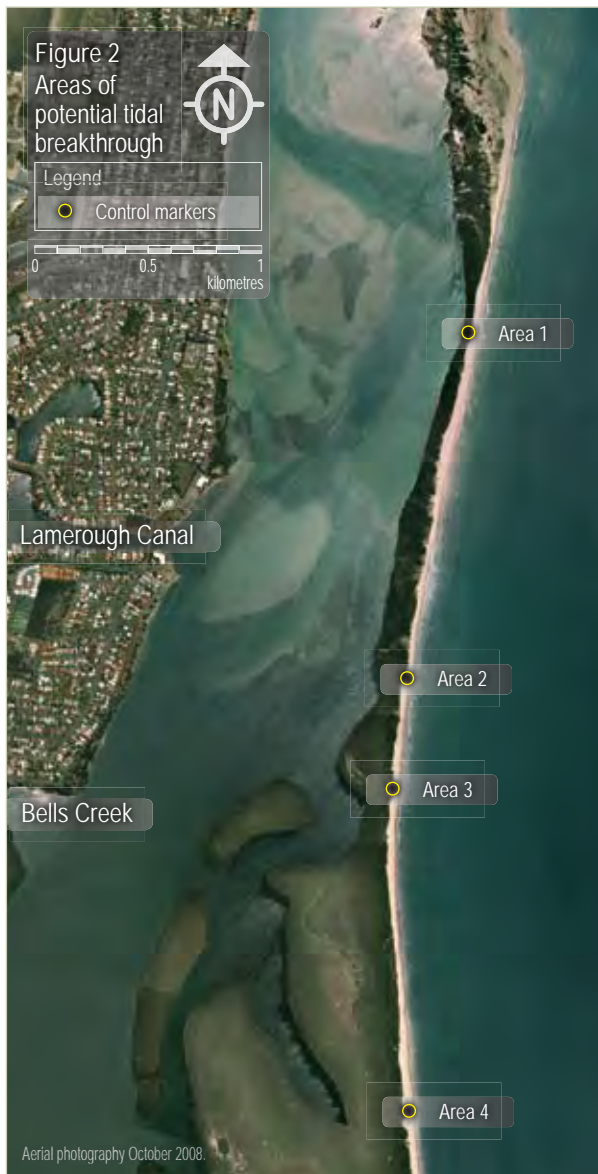
Along the northern end of Bribie Island four locations have been identified by DERM which are considered vulnerable to a breakthrough. The four locations are narrow with low dunes and have experienced major wave overtopping events in the last two years (refer to Figure 2).

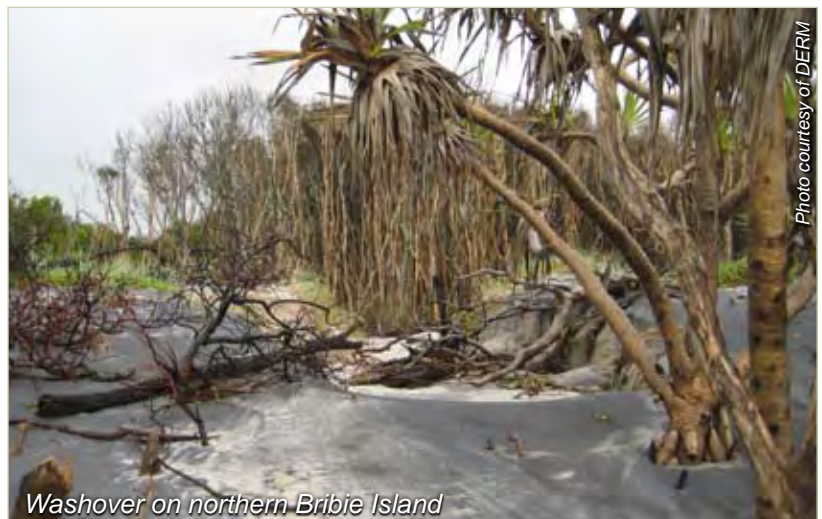
Washover on northern Bribie Island

In this instance a tidal breakthrough is when storm waves wash across northern Bribie Island lowering the dunes. As the level lowers tidal flows can then continue to deepen the channel which forms a new deep entrance to Pumicestone Passage. The process may take days or years and is dependent on weather and tide conditions, especially storms and cyclones.

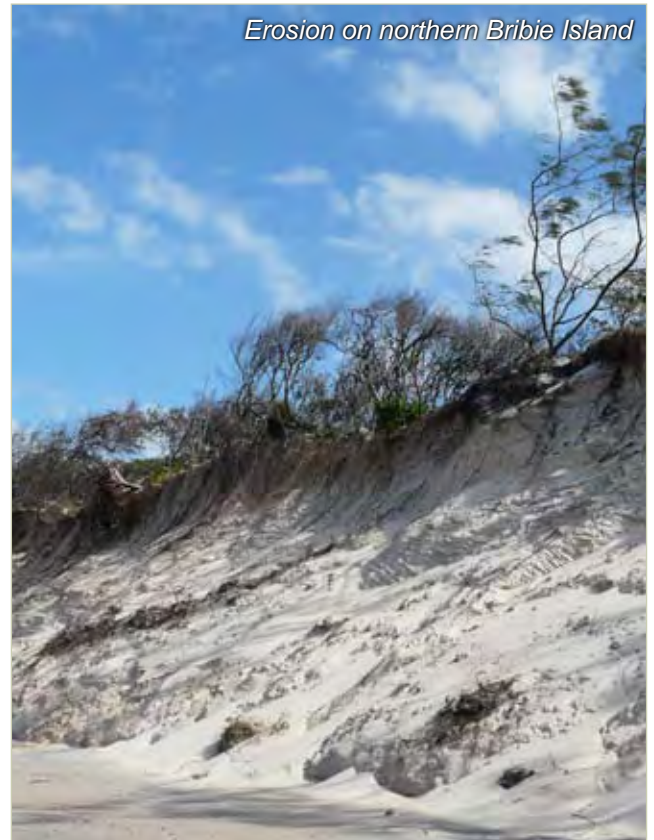
Erosion on northern Bribie Island

The northern five kilometres of Bribie Island has narrowed by up to 100 metres since 1948. The Department of Environment and Resource Management (DERM) states that the erosion appears to be a long-term natural process measured in the hundreds and perhaps thousands of years.

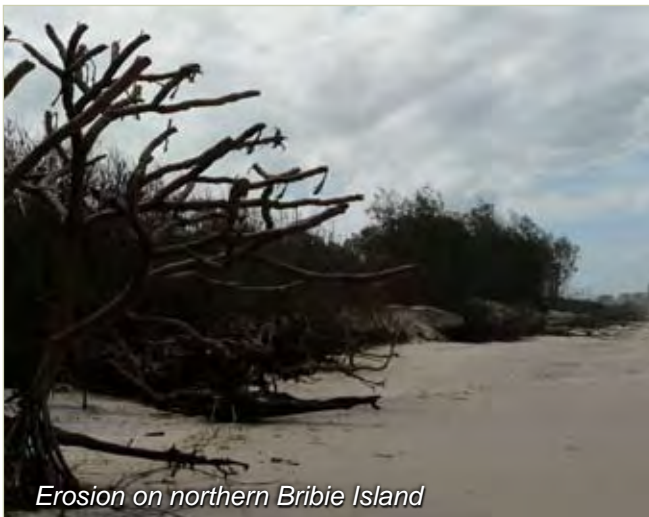
*Erosion on northern Bribie Island*
