Erosion on the ocean side of Bribie Island

PUMICESTONE
PASSAGE
ADVISORY
TASK FORCE

Prepared by Pumicestone Passage Advisory Task Force
© June 2008 Sunshine Coast Regional Council

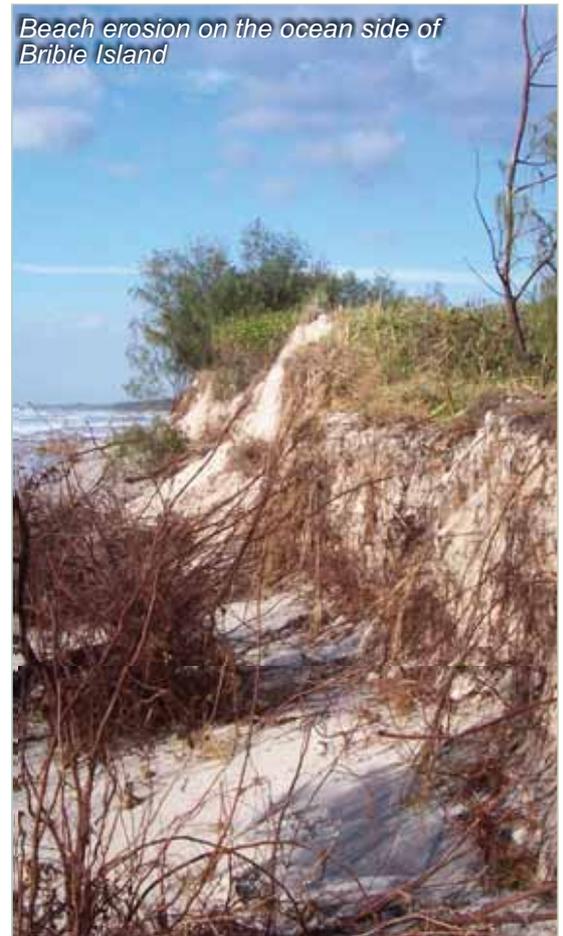
Beach erosion on the ocean side of Bribie Island

The entrance to the Pumicestone Passage is always subject to change. South of the entrance, retreat of the shoreline on the ocean side is greater than the Passage side. On the ocean side of northern Bribie Island, the long term trend of erosion is an average rate of 1 metre per year, but can be up to 10 metres during storm events (refer to Figure 1).

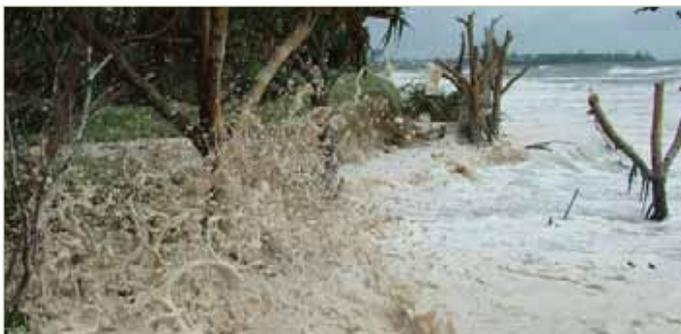
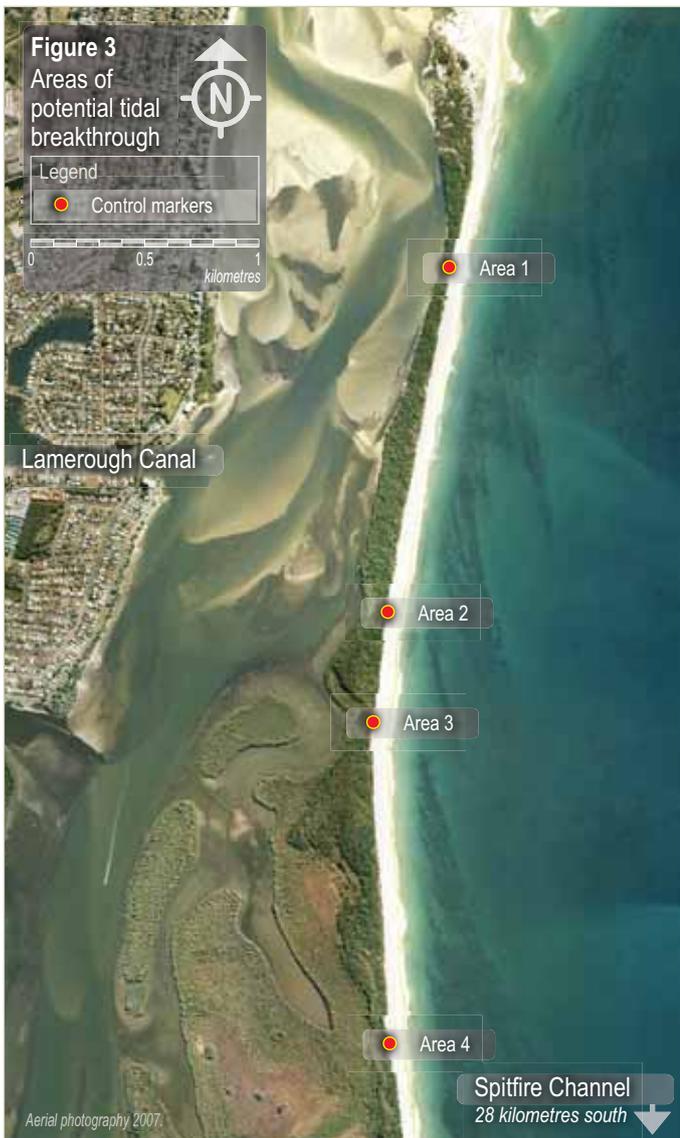
Sand eroded on the ocean side is lost by wave and tide action to the south, the north and into the Passage (refer Figure 2).

There are four narrow sections of Bribie Island where the dunes are also low (refer Figure 3). It is anticipated that in these areas, waves from the ocean side of Bribie Island will wash over the foredune and lower the sand surface level. The tides will then scour out a tidal channel in these lower lying areas.

If a new entrance were to form north of Lamerough Canal there would probably be very little impact on Golden Beach. The entrance has been well south of its existing position before (refer Figure 4).

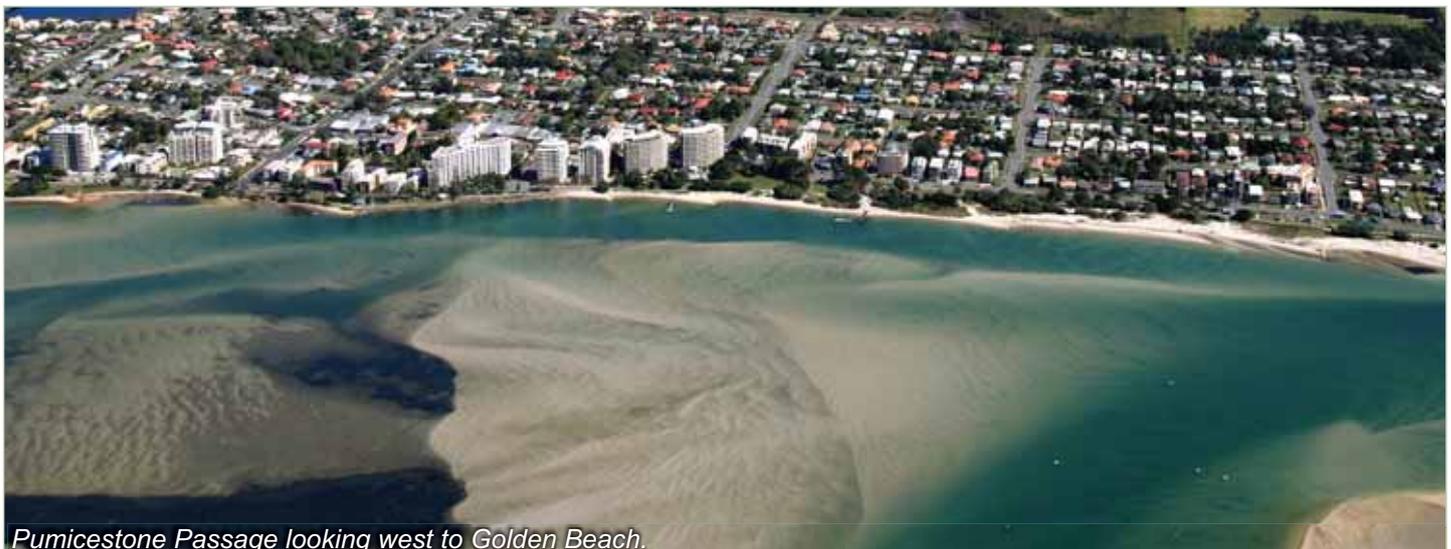
Pumicestone Passage looking west to Golden Beach.

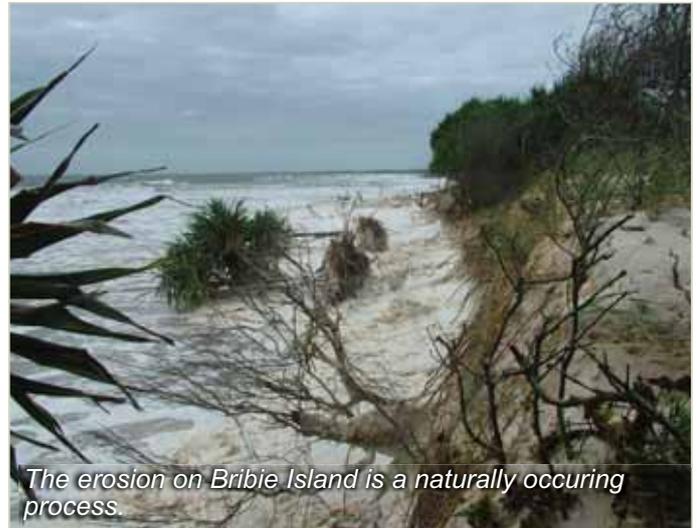
The erosion on Bribie Island is a naturally occurring process.

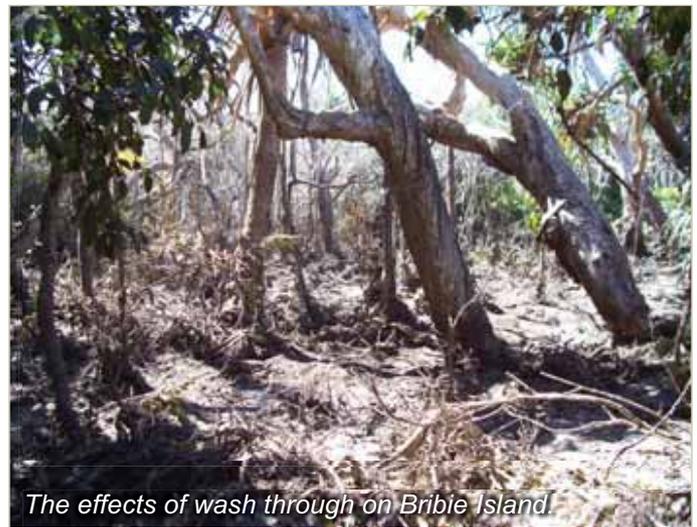
The effects of wash through on Bribie Island.

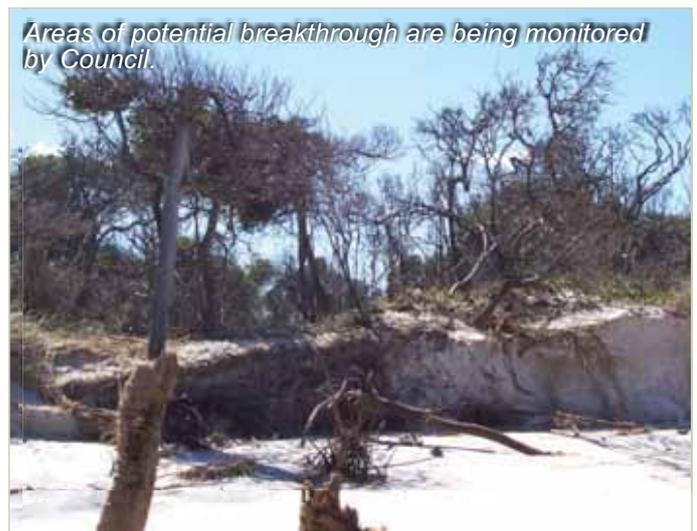
Areas of potential breakthrough are being monitored by Council.

Council is monitoring the four areas of potential tidal breakthrough by aerial and ground surveys and site inspections.
